Crack Discoloration

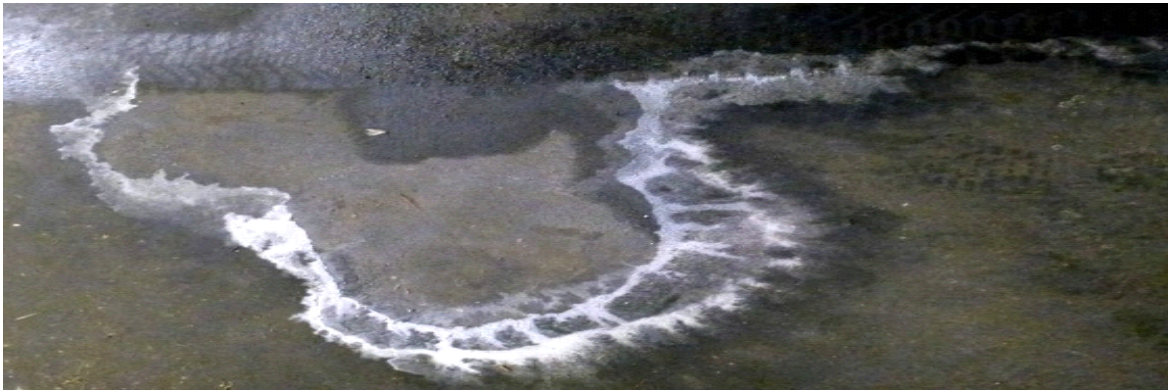
Crack discoloration is a common issue that arises when water comes up through the pavement where cracks or pavement failure is occurring. As the days get warmer, the sun heats up the pavement and draws the moisture back to the surface. If you sealcoat a parking lot and notice that the cracks, alligatored areas or low spots in the pavement have a discoloration of the sealer, typically brown, that is due to the sealer re-emulsifying. In other words, the sealer reabsorbs the water.

White coloring may also be seen in the cracks or white staining on the surface due to salts. These salts are from winter deicers resulting from excessive use of salt on parking lots during the winter months or from natural earth salts coming to the surface known as efflorescence. The white stain is most common on pavements composed of limestone materials and is caused by the leaching of limestone dust from the base materials that lie just beneath the blacktop surface.

When spring rains seep beneath asphalt, they are later pulled back up to the surface by the sun's heat. As the water evaporates, it can leave behind a white or yellow mineral deposit in the cracks or on the pavement surface. These stains or deposits are usually washed away over time. Typically, by fall, most have disappeared.
